Inside Out
INSPECTOR SERVICES

12345 Dreamhome Lane, KiPiSn, WA 98321

Client(s): Happy Homeowner
Agent(s): Savvy Agent
WSDA ICN: Sample Report 2018

Date: November 09, 2018

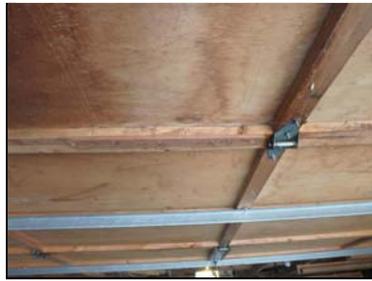
2.6 Item 1(Picture)

The garage door(s) at the front of the building is damaged at the panel. This is a maintenance issue and is for your information. A qualified contractor should inspect and repair as needed.

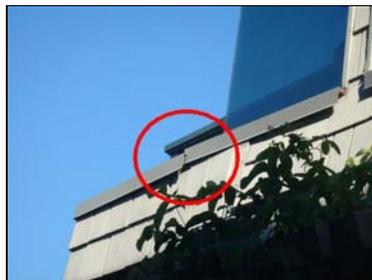
3.1 Item 1(Picture)

(1) The cap flashing at the rear of the building, left side (facing front) is not properly installed. This area is vulnerable to water intrusion. Further investigation is necessary to determine the extent of damage. A qualified contractor should inspect and repair as needed.

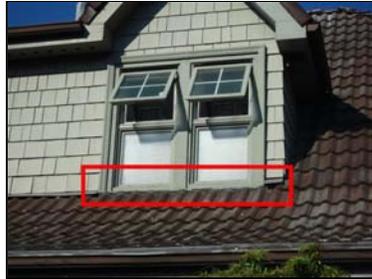
3.1 Item 2(Picture)

🔧 (2) The counter flashing at the front of the building is missing. This area is vulnerable to water intrusion. Further investigation is necessary to determine the extent of damage. A qualified contractor should inspect and repair as needed.

Asphalt-based patching materials are considered a temporary repair and may be prone to water intrusion. Monitor and correct as necessary.

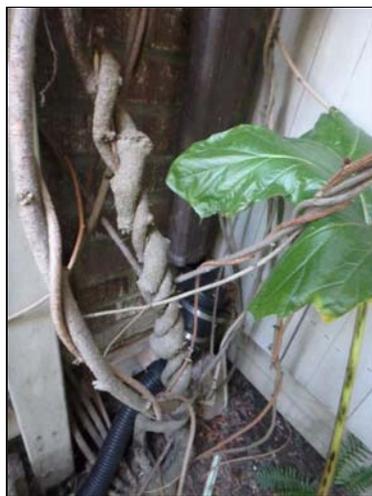
3.4 Item 1(Picture)

🏠 📉 (1) The gutter(s) are holding water due to incorrect slope towards downspout at several connections. Improper drainage of roof runoff can cause damage to roofing material, siding and the foundation. A qualified person should repair or replace as needed.

🏠 📉 (2) Downspouts are not properly extended to move water away from the foundation. Recommend installation of proper extensions/splash blocks to discharge water away from foundation a minimum of 5' in most cases. Water pooling at areas close to the foundation may cause water intrusion of the structure and damage to the foundation wall.

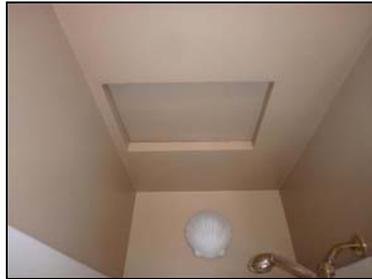
3.5 Item 1(Picture) Attic access

(2) The attic access in the guest bath is a difficult access point. This is for your information. A qualified person should repair or replace as needed.

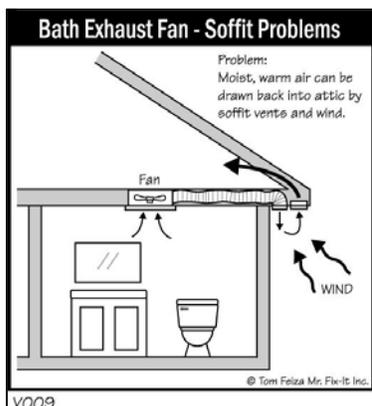
3.6 Item 1(Picture)

(3) Ventilation fan vents into soffit and may cause moisture damage to the insulation/framing. Recommend rerouting through roof vent when the roof covering is replace.

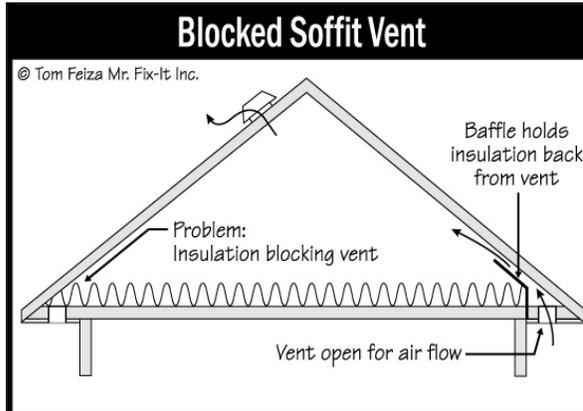
3.7 Item 1(Picture) Blocked soffit

(3) Baffles are missing from the framing. Baffles prevent insulation from blocking the soffit vent(s). These should be repaired to allow for proper ventilation of the attic. A qualified person should repair or replace as needed.

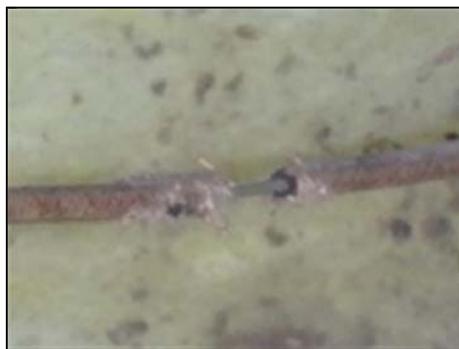
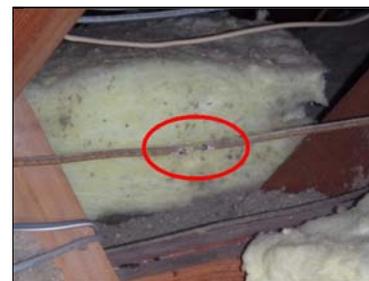
Damaged or exposed wiring sheathing is damaged/deteriorated in areas above the Master bath in attic. Electrical issues are considered a hazard until repaired. I recommend a qualified licensed electrical contractor correct.

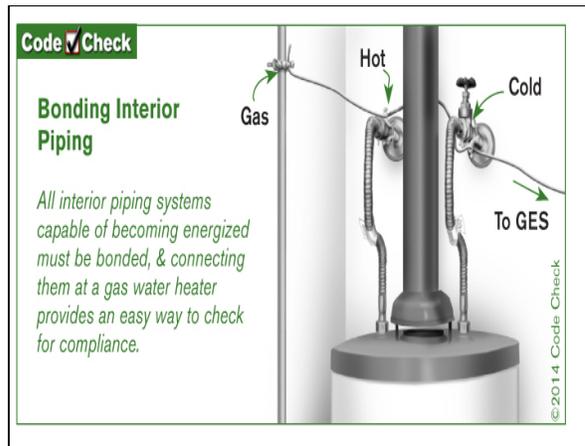
4.2 Item 1(Picture) Bonding at the interior

+ (4) I could not locate the bond wire at the gas line. Bonding jumpers are wires or other metal (gas and water lines) that connect pieces of equipment to prevent any possible voltage potential between them. This is a safety issue and needs to be repaired. Recommend further evaluation by a qualified electrician.

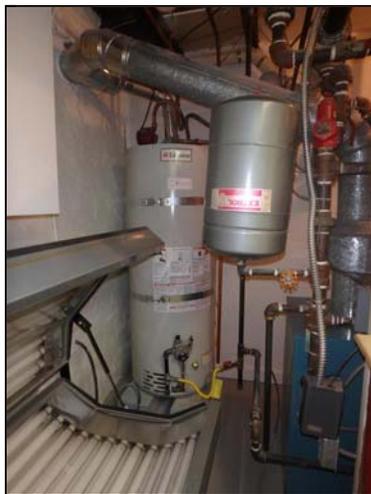
5.3 Item 1(Picture) Water heater

(7) No expansion tank. Expansion tanks are design to absorb the expansion forces of heating/cooling system water while maintaining proper system pressurization under varying operating conditions. They are required in some jurisdictions. A water heater expansion tank is a small tank used in closed water heating systems and domestic hot water systems to absorb excess water pressure, which can be caused by thermal expansion as water is heated. The tank itself is a small container divided in two by a rubber diaphragm. One side is connected to the pipe work of the heating system and therefore contains water. The other, the dry side, contains air under pressure, and normally a car-tire type valve for checking pressures and adding air. When the heating system is empty or at the low end of the normal range of working pressure, the diaphragm will be pushed against the water inlet. As the water pressure increases, so the diaphragm moves compressing the air on its other side. The compressibility of the air cushions the pressure shock, and relieves pressure in the system that could otherwise damage the plumbing system.

(8) The water heater is located in the basement. Model/serial #'s are provided if accessible/legible and for your information only. Recommend installing water alarm at base of water heater. Most water heaters have a life expectancy of 10-15 years. Check with the manufacturer for more accurate life expectancy averages. Water alarms can be purchased through our website at www.insideoutbi.com/store.htm.

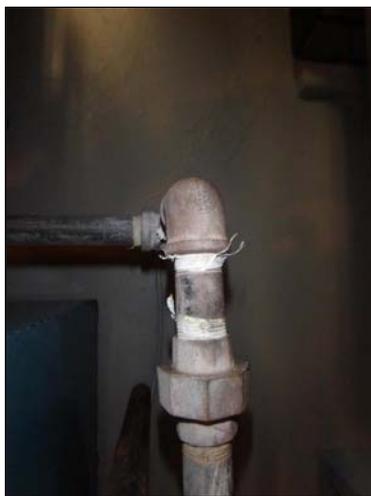
5.5 Item 1(Picture)

🔧 (1) The gas line has been installed with teflon tape in the basement. This is a safety issue and should be repaired. A qualified contractor should inspect and repair as needed

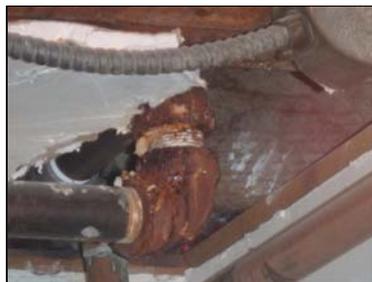
6.3 Item 1(Picture)

- The boiler piping has evidence of previous leaking. While there was no leaking at the time of inspection, we recommend that you monitor and correct as necessary. I recommend service or repair as needed.

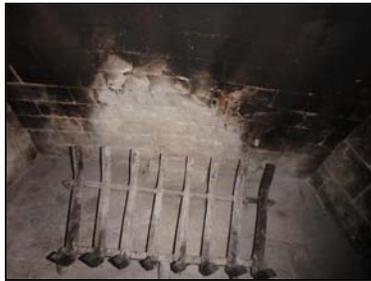
6.6 Item 1(Picture)

🔧 (2) The fire-bricks for the fireplace at the living room are deteriorated. This burn area should be fireproof. Any repairs should be performed according to the manufacturer's specifications.

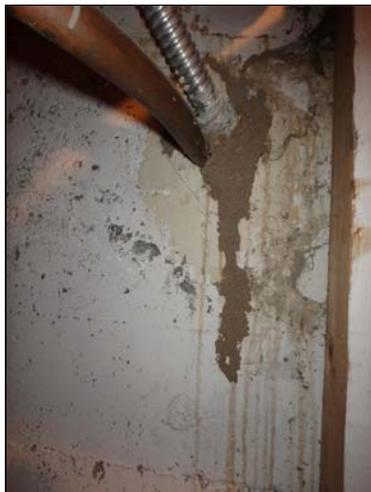
7.0 Item 1(Picture)

Accumulation of frass unique to wood destroying organisms is present at the basement wall of the structure. There are also moisture ant bodies located in this area. Moisture ants are not considered a primary wood destroying organism, however are indicative of a moisture problem. Recommend further evaluation by a qualified pest control operator.

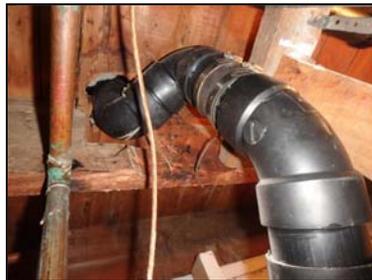
7.3 Item 1(Picture)

(1) The floor joist(s) and subfloor slopes with more deflection than is acceptable at the master bedroom. Further, invasive investigation is necessary to determine extent of damage and what repairs are necessary. A qualified licensed general contractor should inspect further and repair as needed.

(2) Improper notching and boring of joists. Recommend further evaluation and estimate for repair.

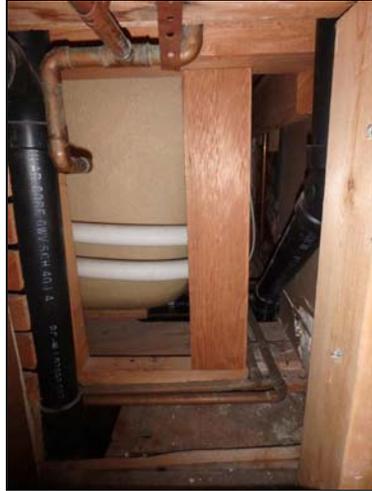
8.3 Item 1(Picture)

+ (2) GFCI is inoperable or not present in the bathroom(s), kitchen(s), or laundry room. Recommend repair or replacement as necessary. Recommend further evaluation by a qualified electrician.

+ (3) While there is an access panel the whirlpool tub motors are recommended to have a minimum of 12"x12" access There is no visible access panel at tub surround. Recommend repair. The Equipment Grounding Conductor (EGC) is missing at the spa tub in the bathroom(s). Electrical issues are considered a hazard until repaired. A qualified licensed electrical contractor should perform repairs that involve wiring.

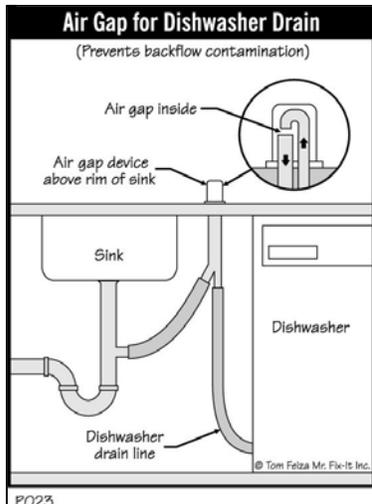
8.4 Item 1(Picture)

🔧 (1) The dishwasher at the lower level did not operate when tested. I recommend repair as necessary.

+ (2) The dishwasher is missing air gap. I recommend repair.

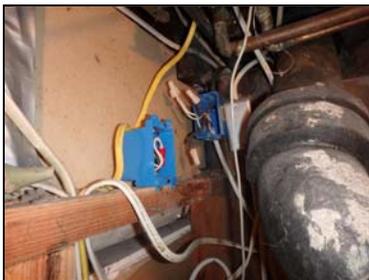
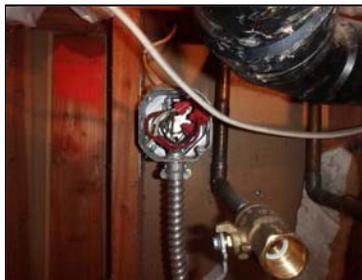
- ⊕ (1) Missing cover plates at junction boxes in the basement. Recommend repair.
