Inside Out
INSPECTOR SERVICES

12345 Dreamhome Lane, KiPiSn, WA 98321

Client(s): Happy Homeowner
Agent(s): Savvy Agent
WSDA ICN: Sample Report 2018

Date: November 09, 2018

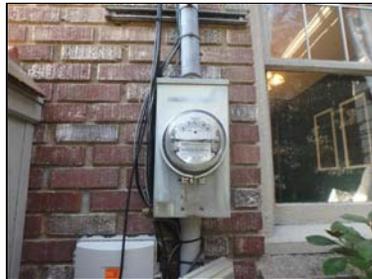
4.0 Item 1(Picture) Electrical Meter

(2) The electrical meter is located at the right side (facing front) of the building. The main panel box is located at the basement kitchen and in the garage. The main disconnect is located at the panel.

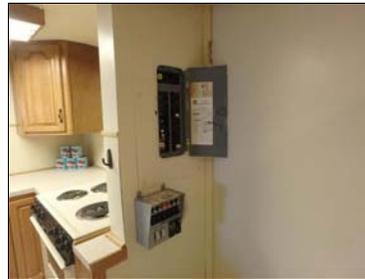
4.0 Item 2(Picture) Electrical panel

(1) In some jurisdictions a panel installed in a kitchen is no longer acceptable. Often, homes are grand-fathered in until updates are needed. Check with your local jurisdiction about specific requirements for your area.

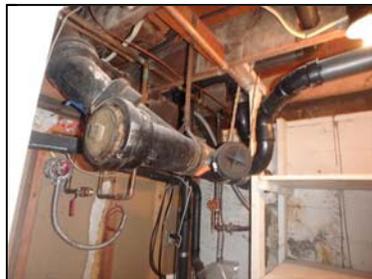
5.1 Item 1(Picture) Sewer access

"Items such as wipes, sanitary products and grease can clog toilets and pipes in your home, causing sewage to overflow in bathrooms and kitchens." For more information on side sewer systems, visit <http://www.seattle.gov/util/MyServices/DrainageSewer/YourPropertysSideSewer/index.htm> The access to the main sewer line is the ABS pipe located in the basement. This is for your information.

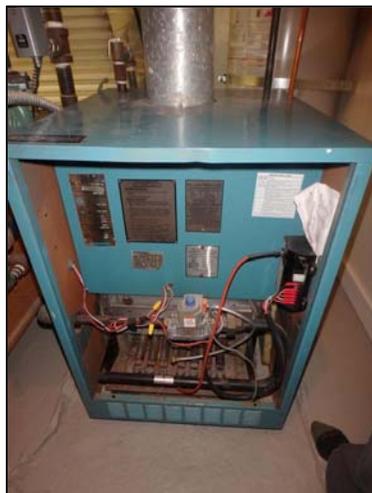
6.0 Item 1(Picture)

- (3) The gas-fired boiler is located in the basement. Model/serial numbers are supplied so that client can research any product recalls or defects. Recall information is not provided as a part of this inspection. Recommend servicing gas appliances a minimum of every 2 years or per manufacturers recommendations. We would encourage a heat ratio test of forced air systems to ensure proper balance to all areas of the building. Recommend installing water alarm at base of high efficiency or condensing heating units. Water alarms can be purchased through our website at www.insideoutbi.com/store.htm.

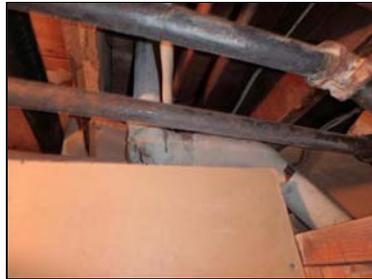
6.8 Item 1(Picture)

In a building of this age it is likely that materials such as insulation, vinyl floor coverings, textured ceilings, etc. contain asbestos. Lab testing of the suspected asbestos material is required to determine the presence of asbestos and is beyond the scope of this inspection.

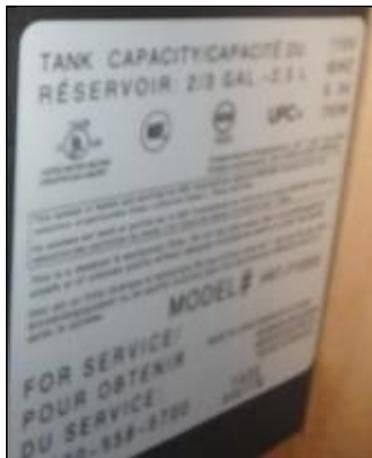
8.2 Item 1(Picture)

(1) Instant-hot systems and water filtration systems are not inspected. Monitor and correct as necessary.
